BEDP ENVIRONMENT DESIGN GUIDE

OFFICE BUILDING RETROFIT AT 55 ST ANDREWS PLACE, MELBOURNE – TURNING A SPARROW INTO A PEACOCK

Roger Kluske and David Clark

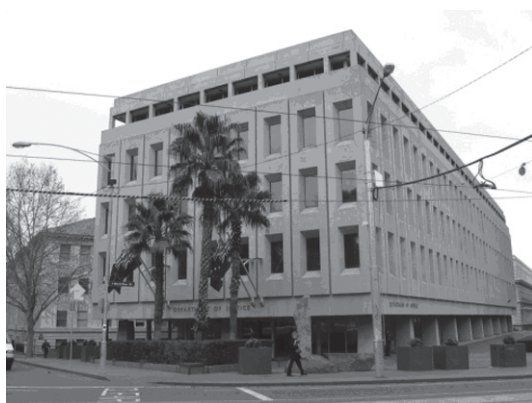
Figure 3. 55 St Andrews Place prior to upgrade
(Source: Cundall, 2005)

- the heavily tinted glazing became very hot in summer causing localised discomfort due to radiant heat, and cracking of the glazing in a number of windows

- To increase the daylight potential, glazing to windows was replaced with clear glass, and external automated blinds were installed to levels 1 to 3 to improve thermal comfort. Most of the building's windows face east and west and receive large solar heat loads. As they were not shaded, the resultant internal heat gain required a lot of energy to air-condition. To manage the solar heat loads through the windows, the glass had been tinted and a reflective film had been applied. The windows were very dark and, consequently,

very little daylight entered the building. Because the windows were dark they also got hot, which meant it was uncomfortable sitting next to the windows when the sun was on them. External blinds were installed to control the solar load before it enters the building, allowing clear glazing to be used instead, significantly increasing daylight into the building.

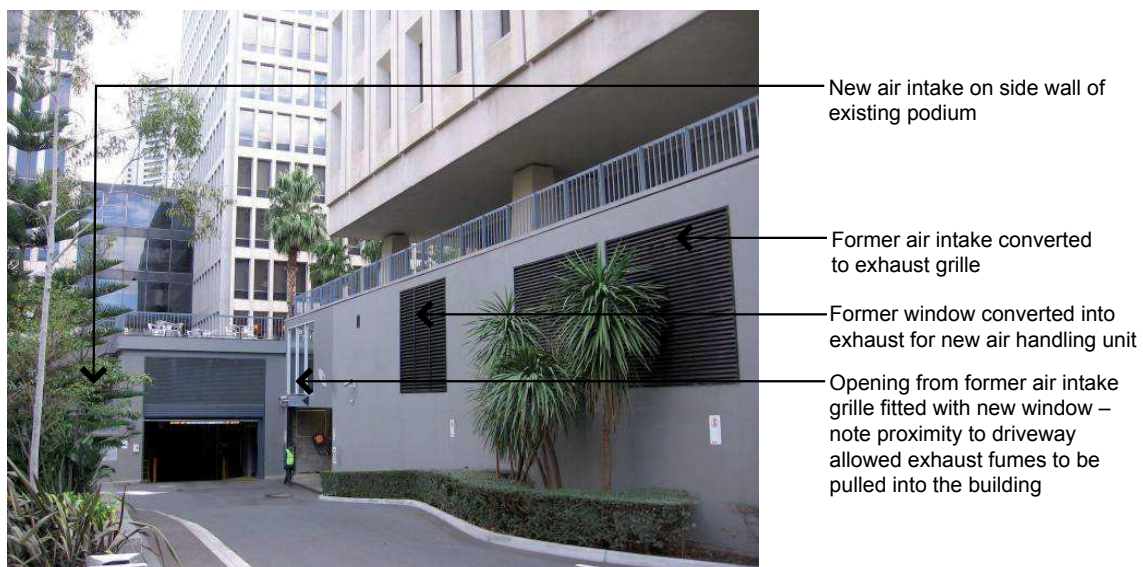
- The air-conditioning fresh air inlet was relocated to improve indoor air quality. This was previously located at the rear of the building in a position that sometimes brought vehicle exhaust fumes into the building from trucks using the service road.

Figure 9. Former intake air grille location next to service road

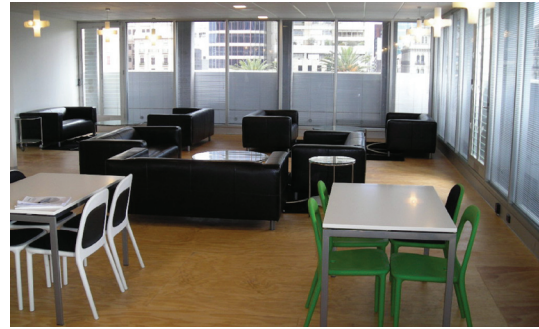
Figure 11. Naturally ventilated resource room

The concrete spandrel around the perimeter of the top floor raises the question – why was full height glass originally installed?

- On Level 4 the large expanse of glazing was reduced by replacing full height glass with an insulated 1.2m high spandrel panel and installing new low-e glass. This reduces heat losses/gains through the façade, improves comfort and increases daylight levels.
